SIDEPower TECHNICAL MEMO

SIDE-POWER - Prop fitting addendum – older 4 & 7HP

SUBJECT : Installation of plastic propellers SIDEPOWER

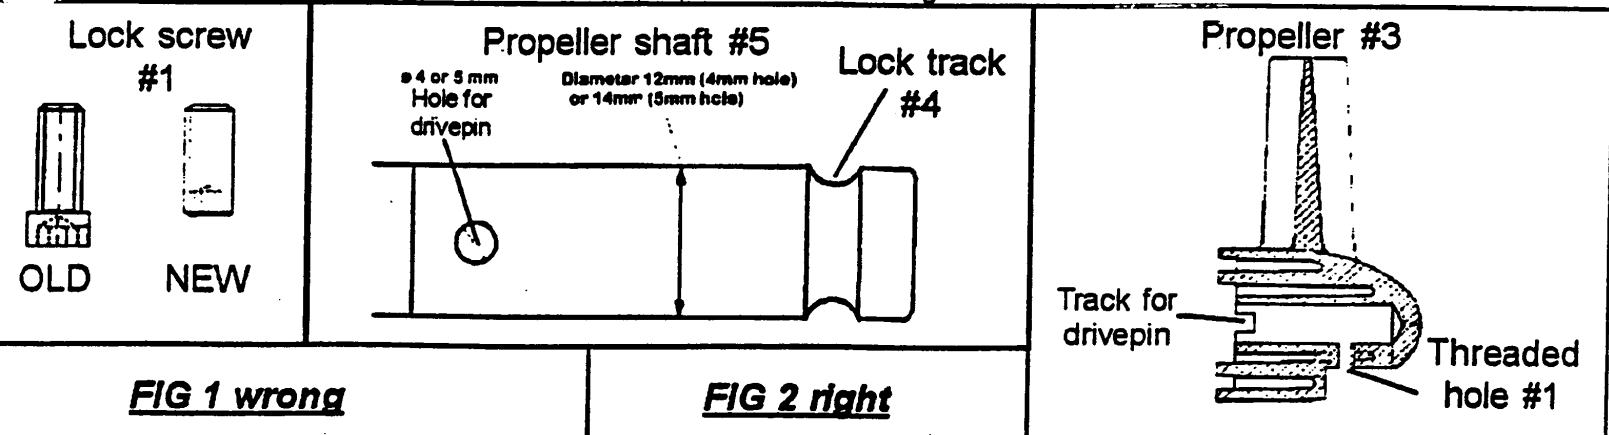
REASON : The problem is caused by the propeller never being correctly fastened. If the propeller have not been pushed all the way in, the set screw (#1) fastened in its treaded hole (#2) in the propeller (#3) does not come in to the lock track (#4) on the propeller shaft (#5) so that it is only pushing against the flat shaft. (SEE FIG.1.) This can hold the propeller for a short while, even when the thruster is being run the way that drags the propeller from the shaft, but the propeller will fall off sooner or later. So this is nothing but an installation mistake.

PS! When a propeller have been damaged, many people does not want to lift the boat out of the water, so they dive to put on the new propeller. This is OK, as long as it is being pushed all the way on to the shaft, which is very difficult under water, as the propeller and propellershaft fits eachother perfectly, so you will compress water inside the propeller that makes it impossible to push the propeller all the way in on the shaft. To avoid this problem, drill a hole in the end of the propeller to let the water come through. (SEE FIG.3.)

Please also make sure that the drive pin is in the propellershaft and also that it is centred.

WARE! There are plastic threads in the propeller, so do not tighten the screw to hard.

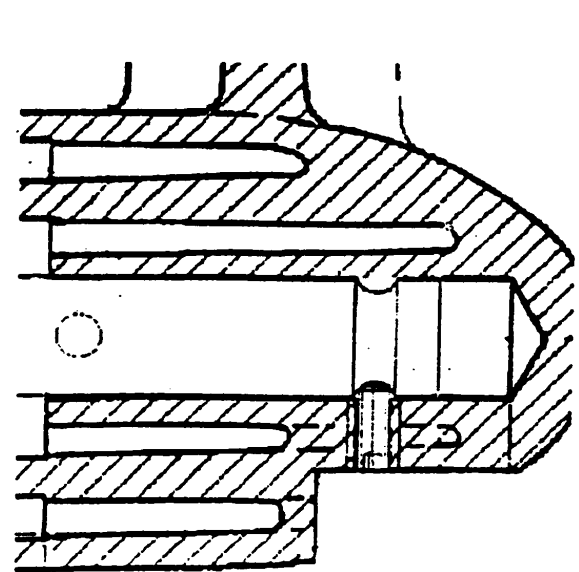
SOLUTION : - Install the propeller correctly on the shaft (SEE FIG.2).
- To make it easier to be sure that the lock screw is correctly in the track, we now supply head-less screws that must be all the way in to the hole for the installation to be correct.
